JACKSONVILLE TRANSPORTATION AUTHORITY

INCIDENT INVESTIGATION

Ferry Collision with Dock

INITIAL REPORT

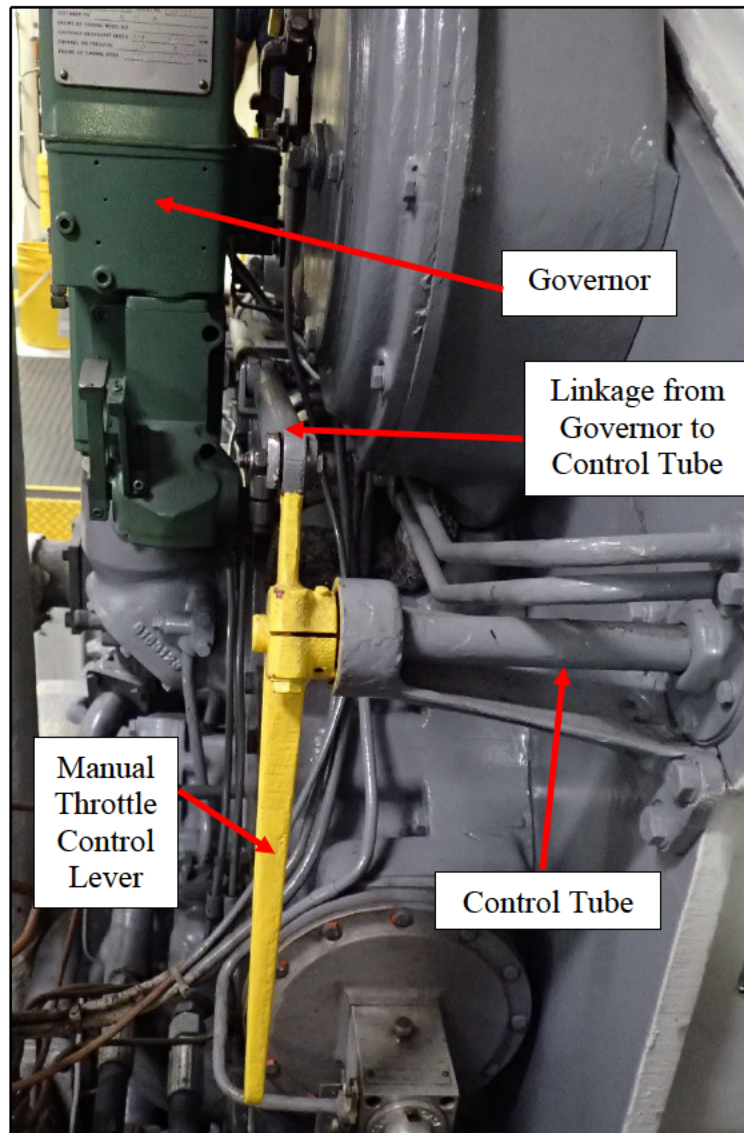
FIGURE 5: B-END ENGINE GOVERNOR, LINKAGE, AND CONTROL TUBE WITH MARKUPS

The idle speed of the B-end engine governor, with no air pressure signal, was set near 350 RPM. In actuating the throttle of the B-end engine manually via the lever in Figure 5, without the engine running, there was no apparent slack or unintended movement in the assembly.

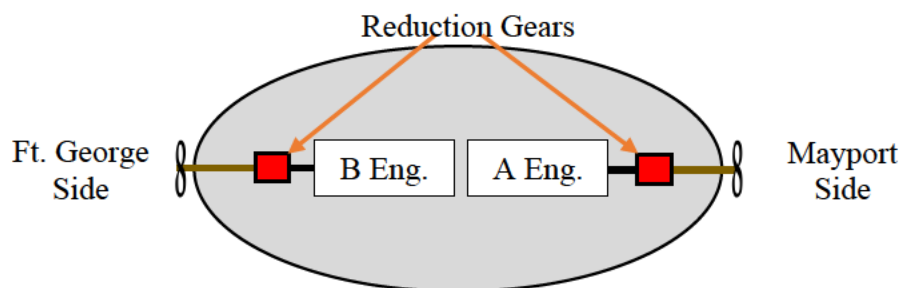
FIGURE 8: JEAN RIBAUT POWERTRAIN GENERAL LAYOUT (NOT TO SCALE)

The *Jean Ribault* is atypical compared to most other marine vessels in that its two main engines oppose each other with a prop at each end of the vessel instead of a single prop or multiple props on one end. There is also a steering rudder on each end of the vessel. Figure 8 illustrates the general layout of the *Jean Ribault*'s powertrain. Note the ovular shape of the hull also illustrated in Figure 1 for orientation purposes.

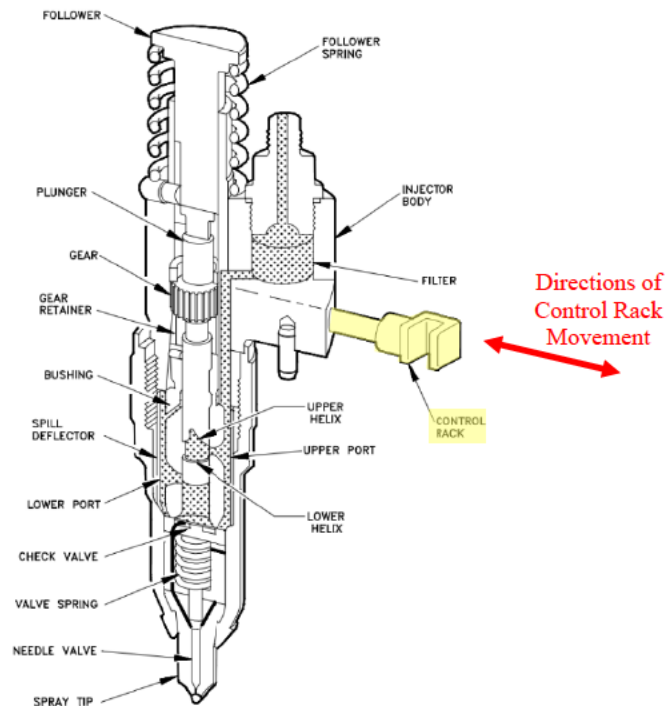
FIGURE 9: FUEL INJECTOR CUTAWAY² WITH MARKUPS

The control racks are connected to the control tubes (one of which is seen in Figure 5) via levers which translate the rotational motion of the control tubes to back-and-forth linear motion. The control tubes are, in turn, what the engine governor is connected to via linkages, as seen in Figure 5. When the control tube is rotated by the governor linkage, the rack levers extending from the control tube linearly move the unit injector racks to alter the amount of fuel injected into the cylinder for that stroke.

Surging throttle or idle of a two-stroke diesel can sometimes be attributed to improper adjustment of the fuel injector control racks relative to the control tube. The positions of the racks must be correctly set in relation to the governor to ensure equal distribution of the load between each cylinder. When a cylinder, or cylinders, are receiving more fuel than others at a constant throttle load, this may result in the engine speed momentarily increasing and then decreasing, or surging.
