JACKSONVILLE TRANSPORTATION AUTHORITY

INCIDENT INVESTIGATION

Ferry Collision with Dock

INITIAL REPORT

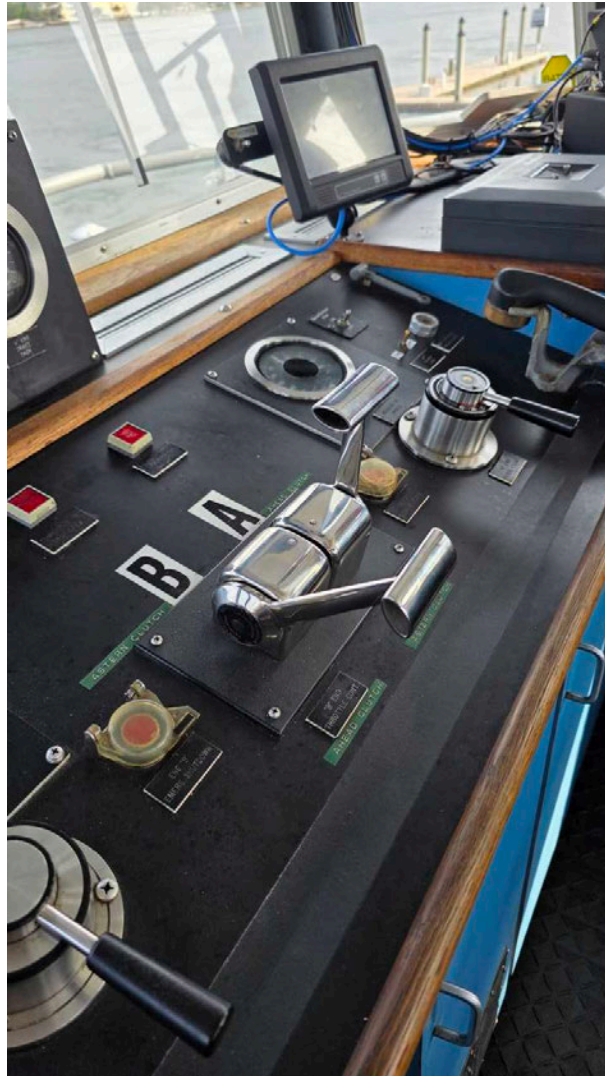
1 7-20250507_090029
B console throttles

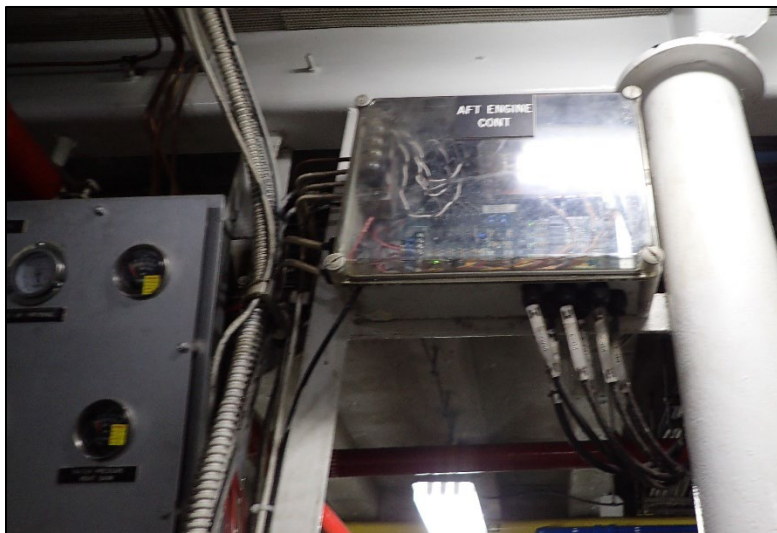
FIGURE 4: B-END ENGINE ELECTRONIC ENGINE CONTROLS

Throttle, clutch, and shaft brake control was managed by an electronic system with the main controllers mounted in the engine room (Figure 4).

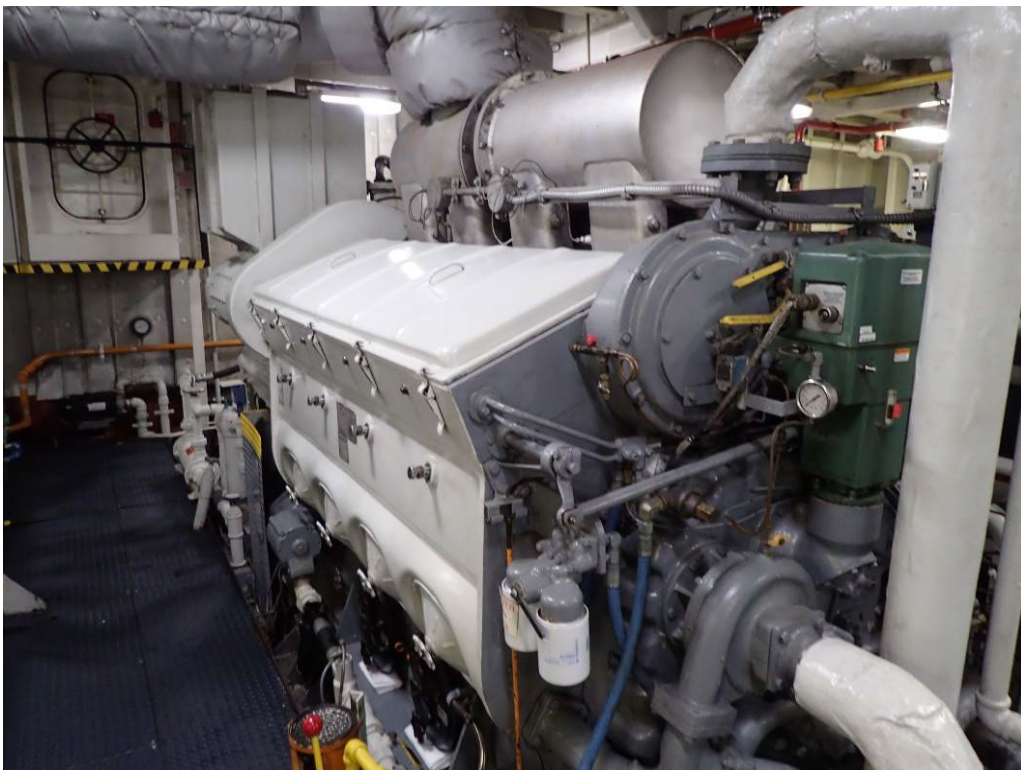
Photograph 26. - "B" Engine

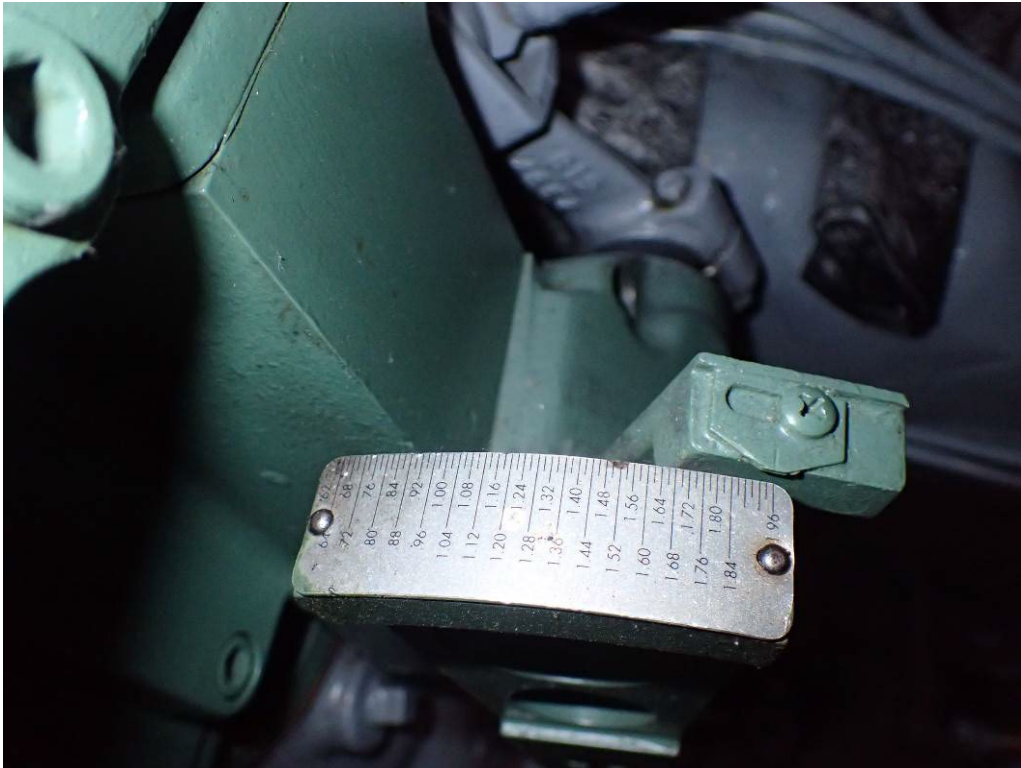
Photograph 42. - "B" Engine Governor Position - Engine Stopped

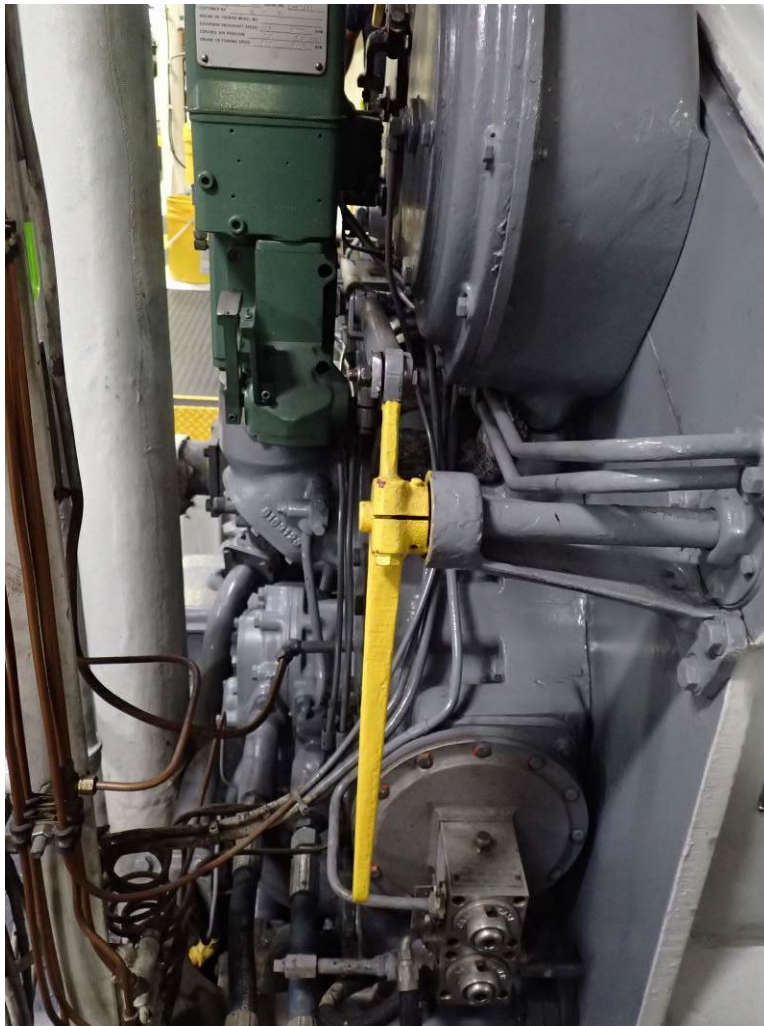
Photograph 43. - "B" Engine Governor Position - Engine Stopped

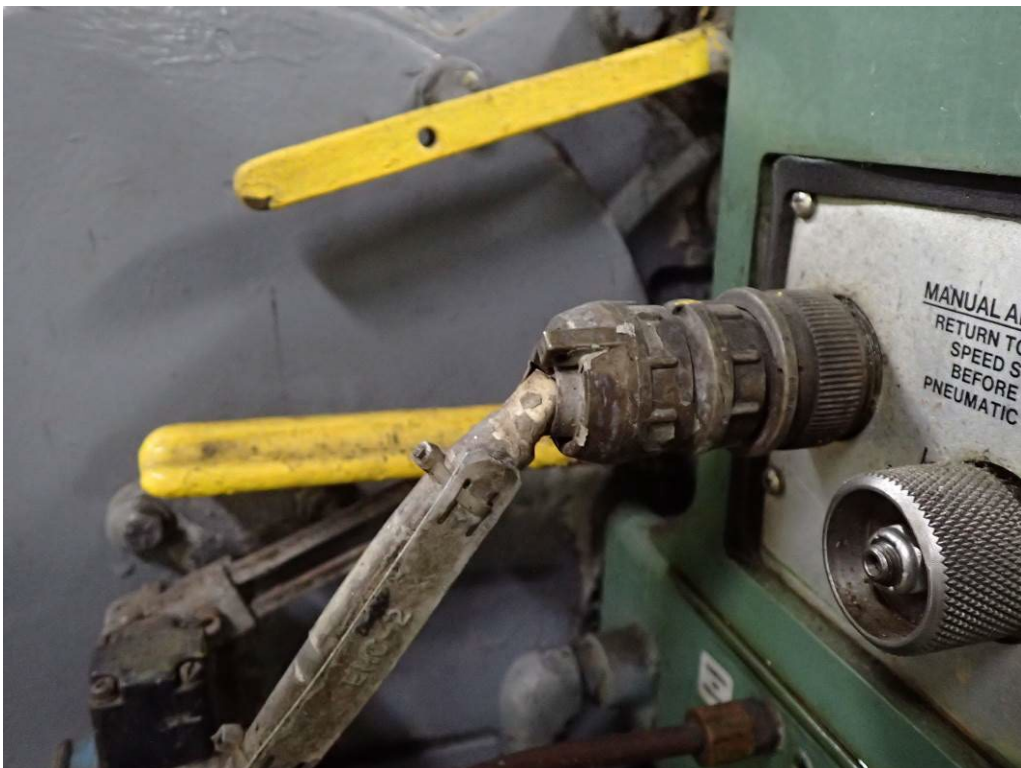
Photograph 45. - "B" Engine Governor

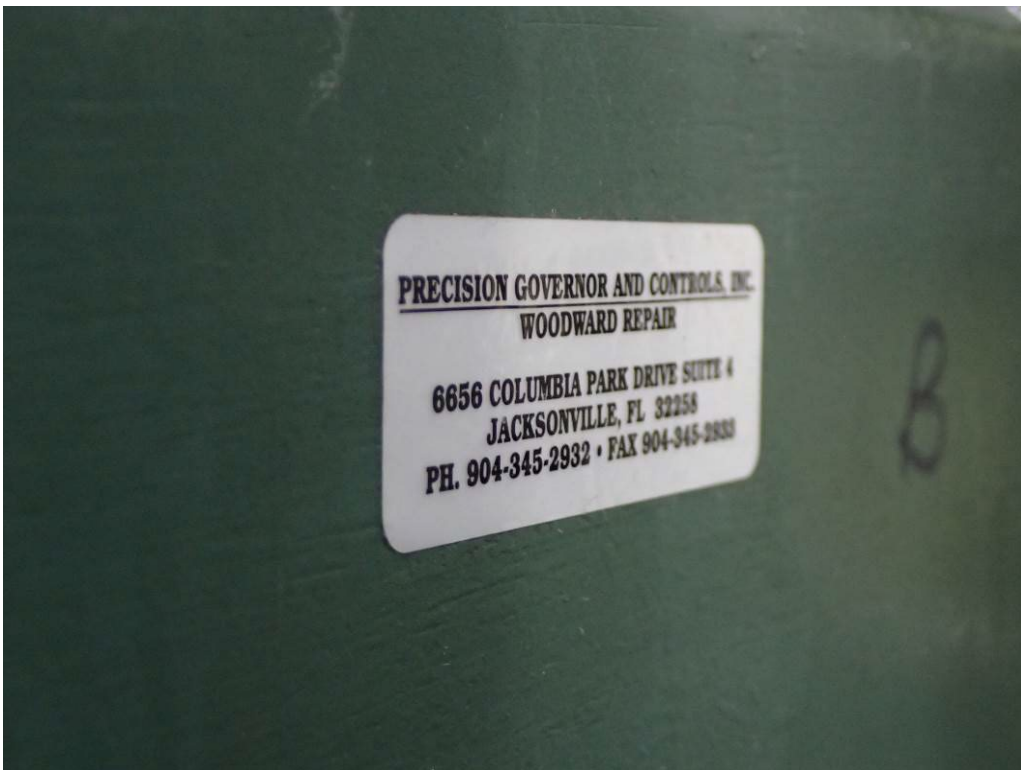
Photograph 49. - "B" Engine Governor and Linkages

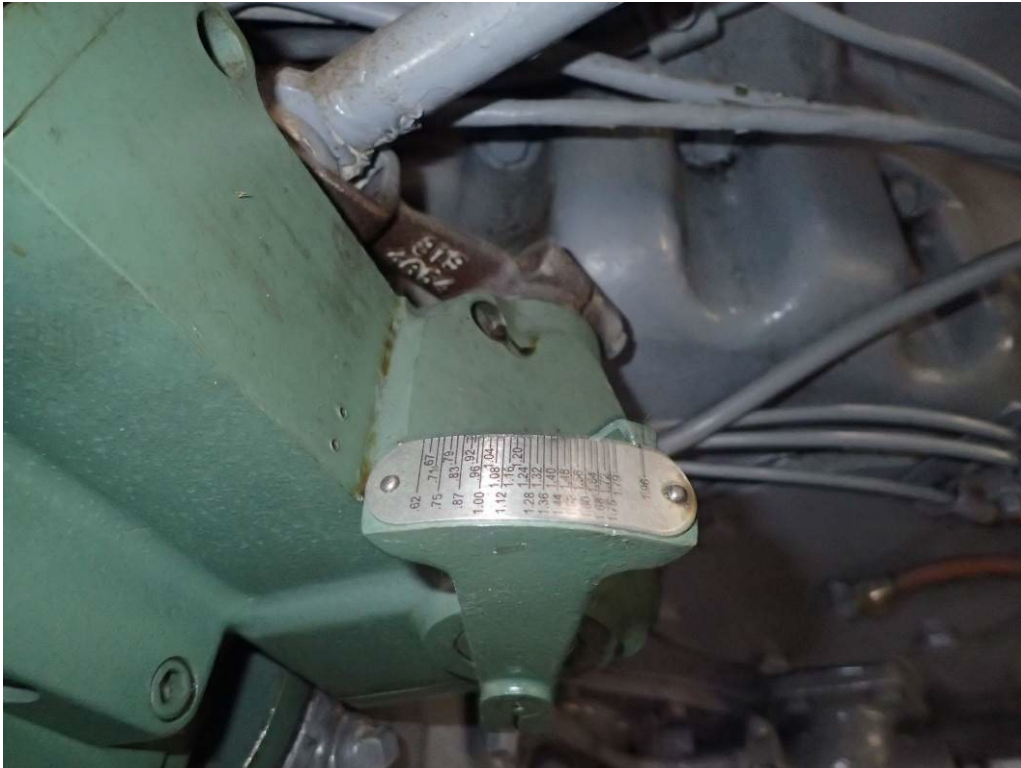
Photograph 52. - "A" Engine Governor and Linkages

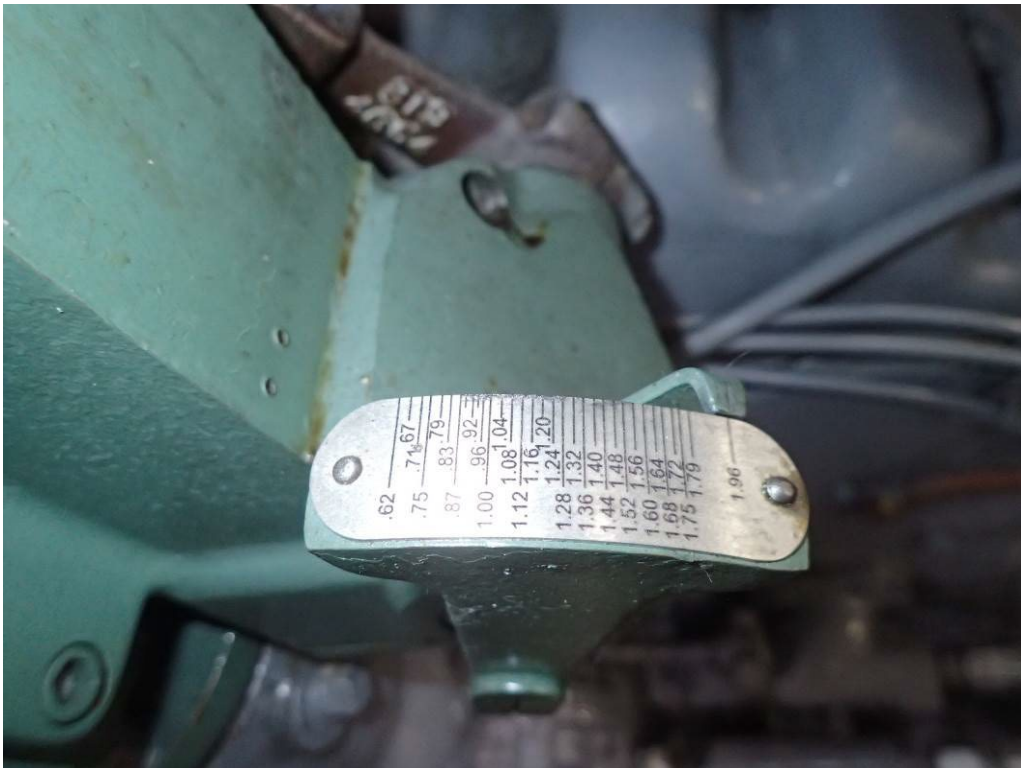
Photograph 53. - "A" Engine Governor Position - Engine Stopped

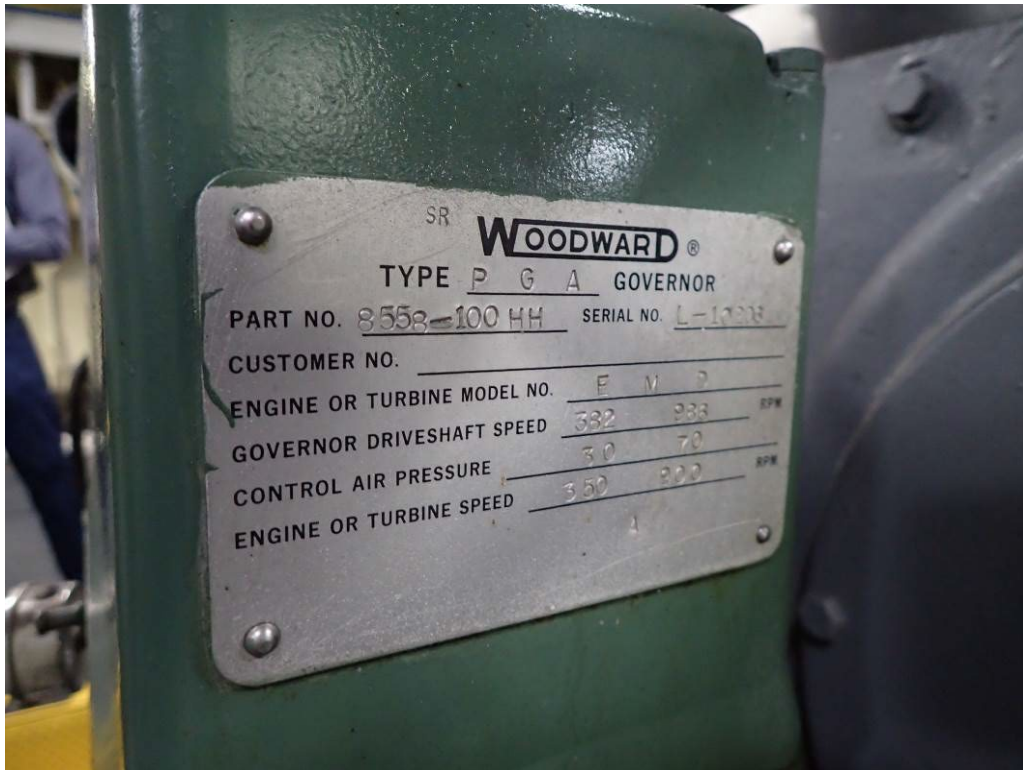
Photograph 54. - "A" Engine Governor Position - Engine Stopped

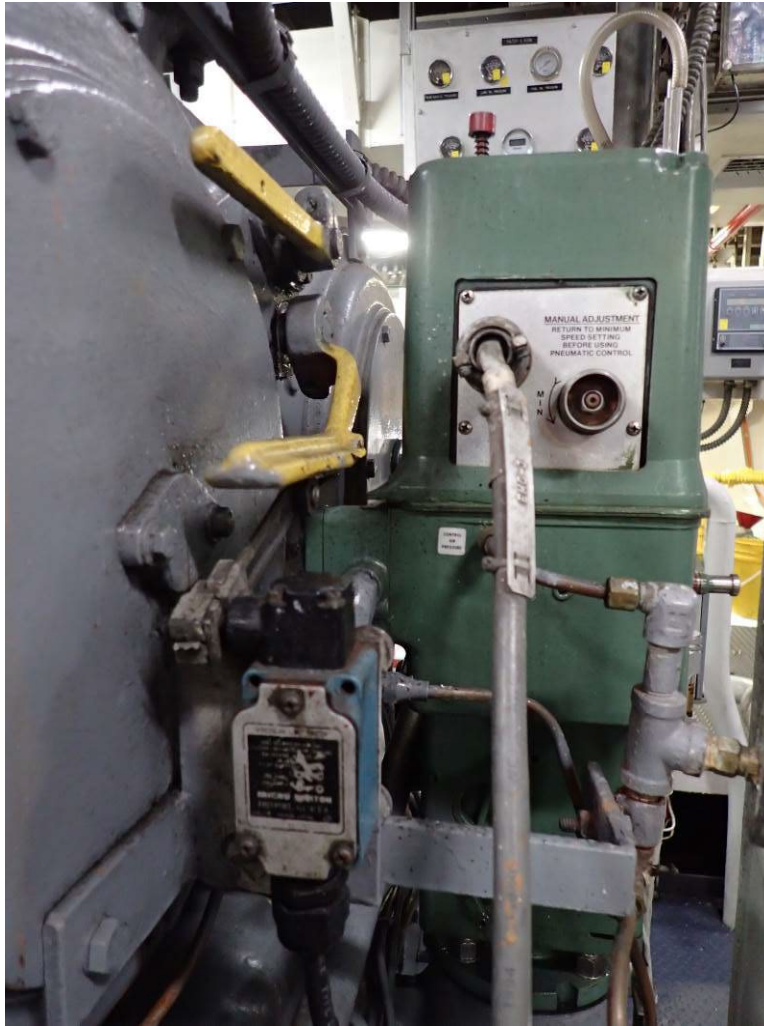
Photograph 57. - "A" Engine Governor and Linkages

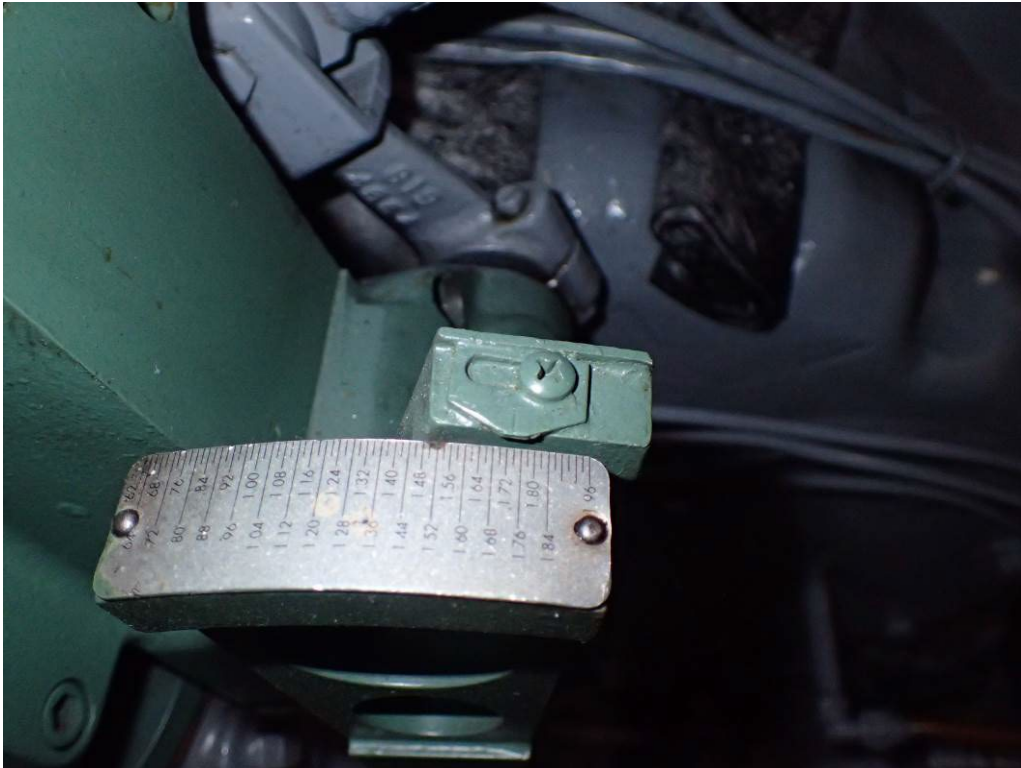
Photograph 70. - "B" Engine Governor Position - Engine Idling
